**Flood Control Project Maintenance**  
**2019 Structure Summary Report**  
**Overall Unit and Item Ratings**

## DWR Sutter Maintenance Yard

### Butte Slough Drainage Structure

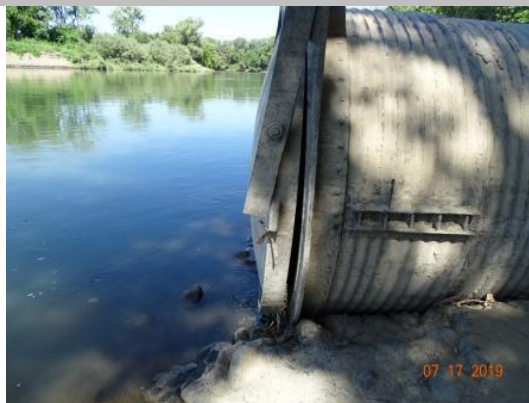
Photo 7 of 7 : ST\_2019\_NA0060\_38\_1\_20190718\_00016.jpg

Side view of the outfall flap gate.

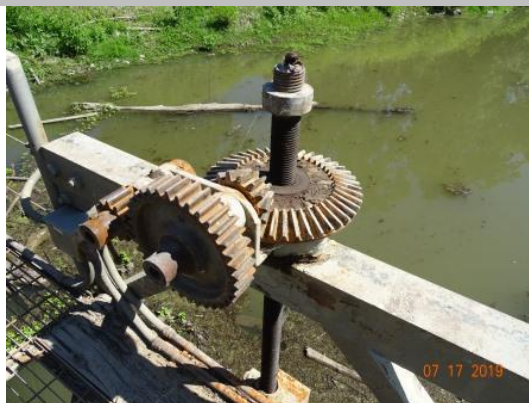
Photo 4 of 8 : ST\_2019\_NA0060\_42\_1\_20190718\_00012.jpg

View of the valve operator with rust on the gears.

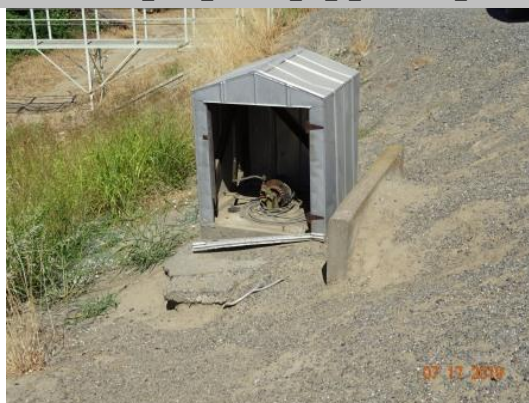
Photo 5 of 8 : ST\_2019\_NA0060\_42\_1\_20190718\_00015.jpg

View of the abandoned in-place hoist system.

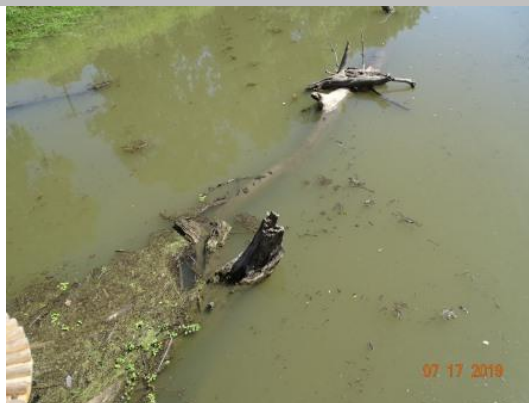
Photo 1 of 1 : ST\_2019\_NA0060\_42\_2\_20190718\_00020.jpg

LM Start	0.00	Rating **	M	Issue No.	2
LM End	0.00	Issue Type +	Ma	Location *	
Category	Structures & Concrete Lined Channels			GPS Latitude/Longitude	
				Start	End
Item	Vegetation & Obstructions			39.194972 °	39.194972 °
				-121.936088 °	-121.936088 °
DWR ID	DWR_NA0060_42_t_2012_2				
Action/Comments					
Inspector Comments: Some logs jammed near the slide gates which may impact proper operation of the structure.

View of the log jammed next to the slide gate.

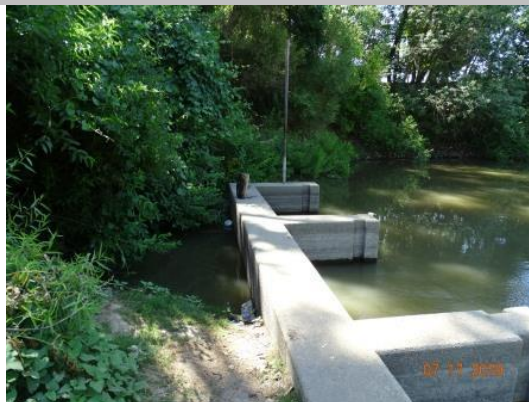
Photo 2 of 2 : ST\_2019\_NA0060\_42\_4\_20190718\_00022.jpg

View of the active erosion around the leftside of the headwall.

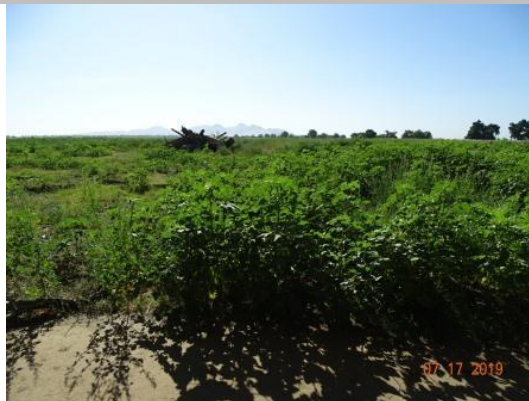
Photo 1 of 2 : ST\_2019\_NA0060\_55\_2\_20190718\_00022.jpg

View of the typical vegetation found on the downstream side of the weir.

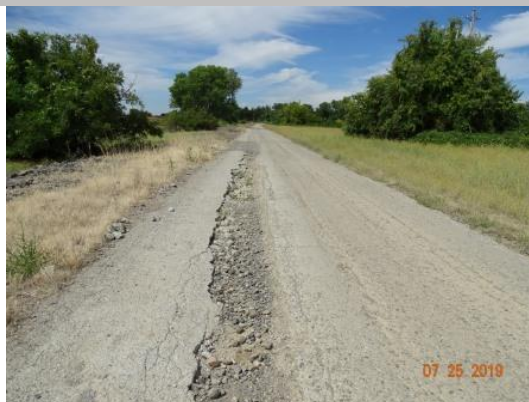
Photo 1 of 1 : ST\_2019\_NA0060\_225\_15\_20190726\_00010.jpg

View of the damaged concrete surface.

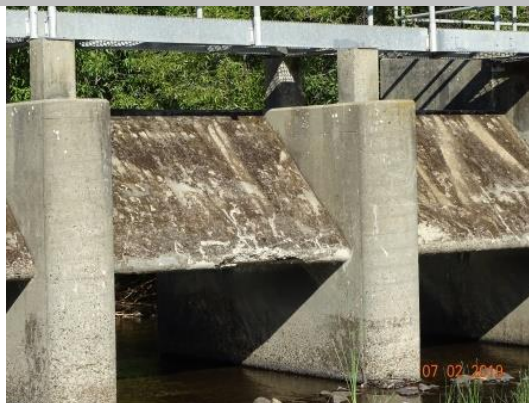
Photo 1 of 1 : ST\_2019\_NA0060\_9\_15\_20190710\_00034.jpg

View of one of the inlets that is showing some wear and spalling and rebar is exposed, 2019.

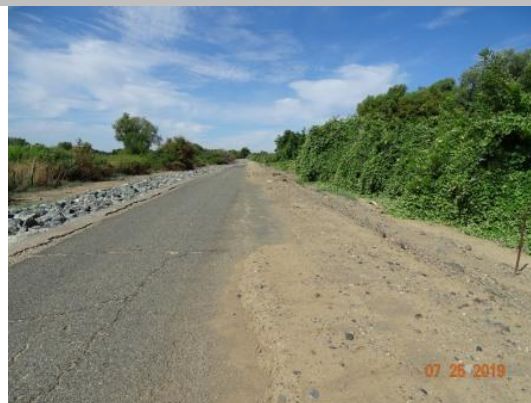
Photo 3 of 3 : ST\_2019\_NA0060\_228\_1\_20190731\_00015.jpg

View of the temporary berm on the upstream side of the overflow structure.

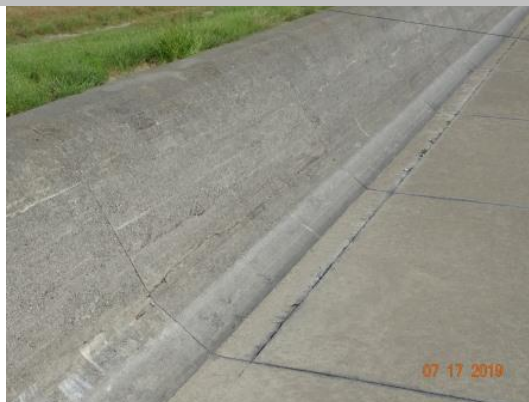
Photo 1 of 2 : ST\_2019\_NA0060\_4\_15\_20190718\_00028.jpg

View of a longitudinal crack along a vertical concrete section.

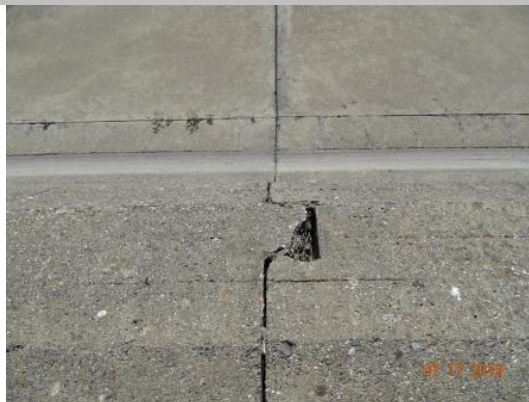
Photo 2 of 2 : ST\_2019\_NA0060\_4\_15\_20190731\_00029.jpg

View of the spalling at one of the joints.

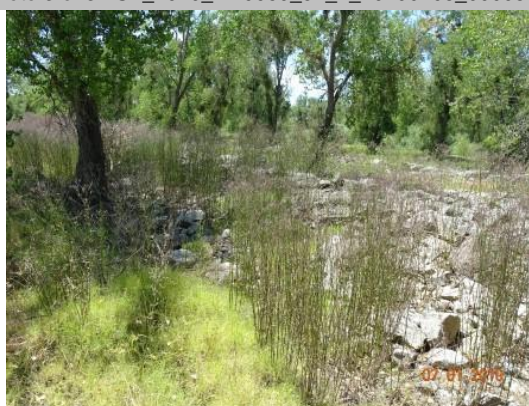
Photo 3 of 3 : ST\_2019\_NA0060\_54\_2\_20190708\_00008.jpg

View of the vegetation around the rock weir looking upstream, 2019.

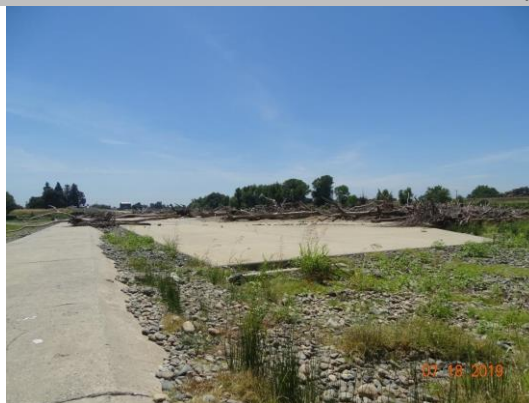
Photo 2 of 2 : ST\_2019\_NA0060\_3\_2\_20190723\_00036.jpg

Additional view of trees at the weir inlet. Summer 2019.

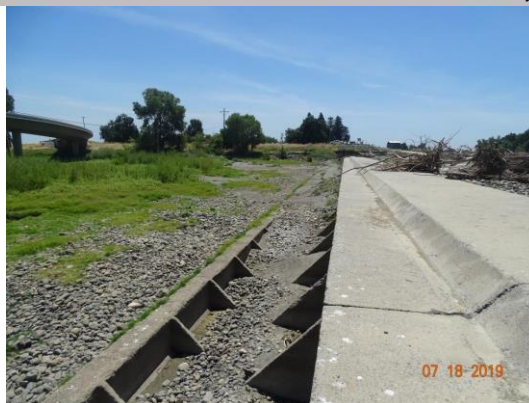
Photo 1 of 1 : ST\_2019\_NA0060\_3\_3\_20190719\_00026.jpg

View of the silt and cobble build-up within the weir stilling basin. Summer 2019.

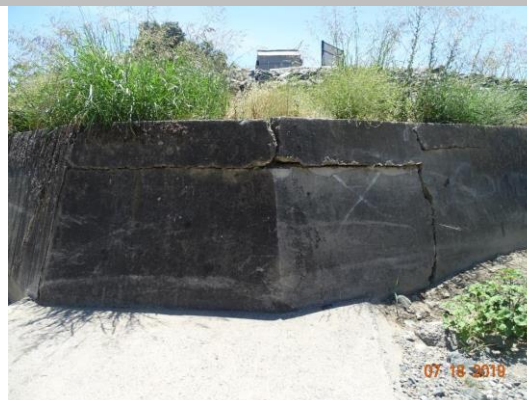
Photo 1 of 4 : ST\_2019\_NA0060\_3\_15\_20190722\_00028.jpg

View of cracking the south abutment. Summer 2019.

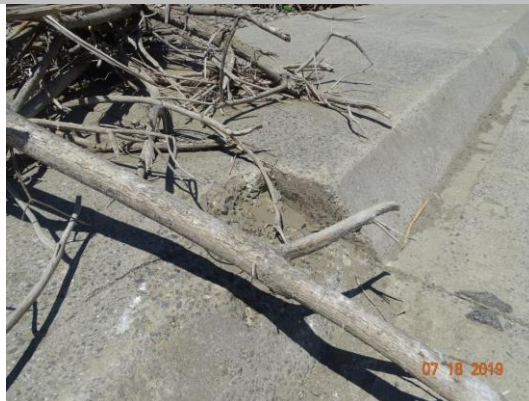
Photo 2 of 4 : ST\_2019\_NA0060\_3\_15\_20190722\_00029.jpg

View of spalling on the weir. Summer 2019.

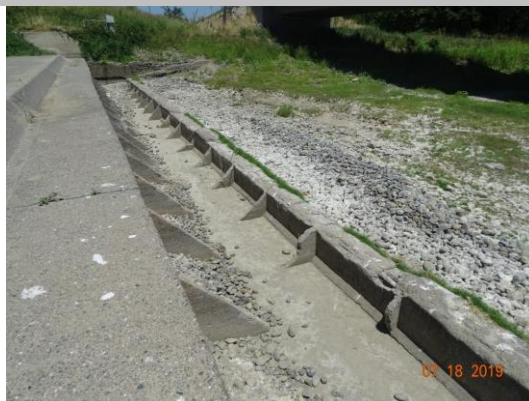
Photo 3 of 4 : ST\_2019\_NA0060\_3\_15\_20190722\_00031.jpg

View of missing counterforts and exposed rebar. Summer 2019.

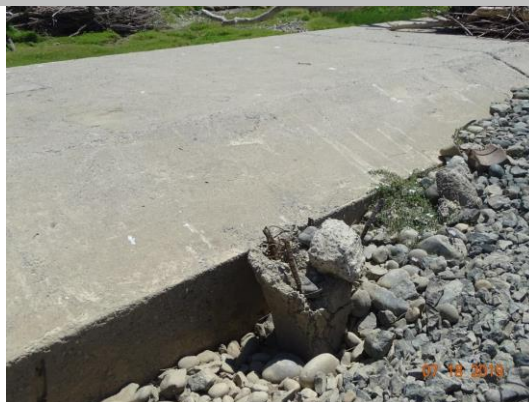
Photo 1 of 2 : ST\_2019\_NA0060\_3\_23\_20190722\_00033.jpg

View of exposed rebar at weir transition. Summer 2019.
